SITE PLAN

PROFILE

PROJECT SITE:
ARMSTRONG
FORD DAM

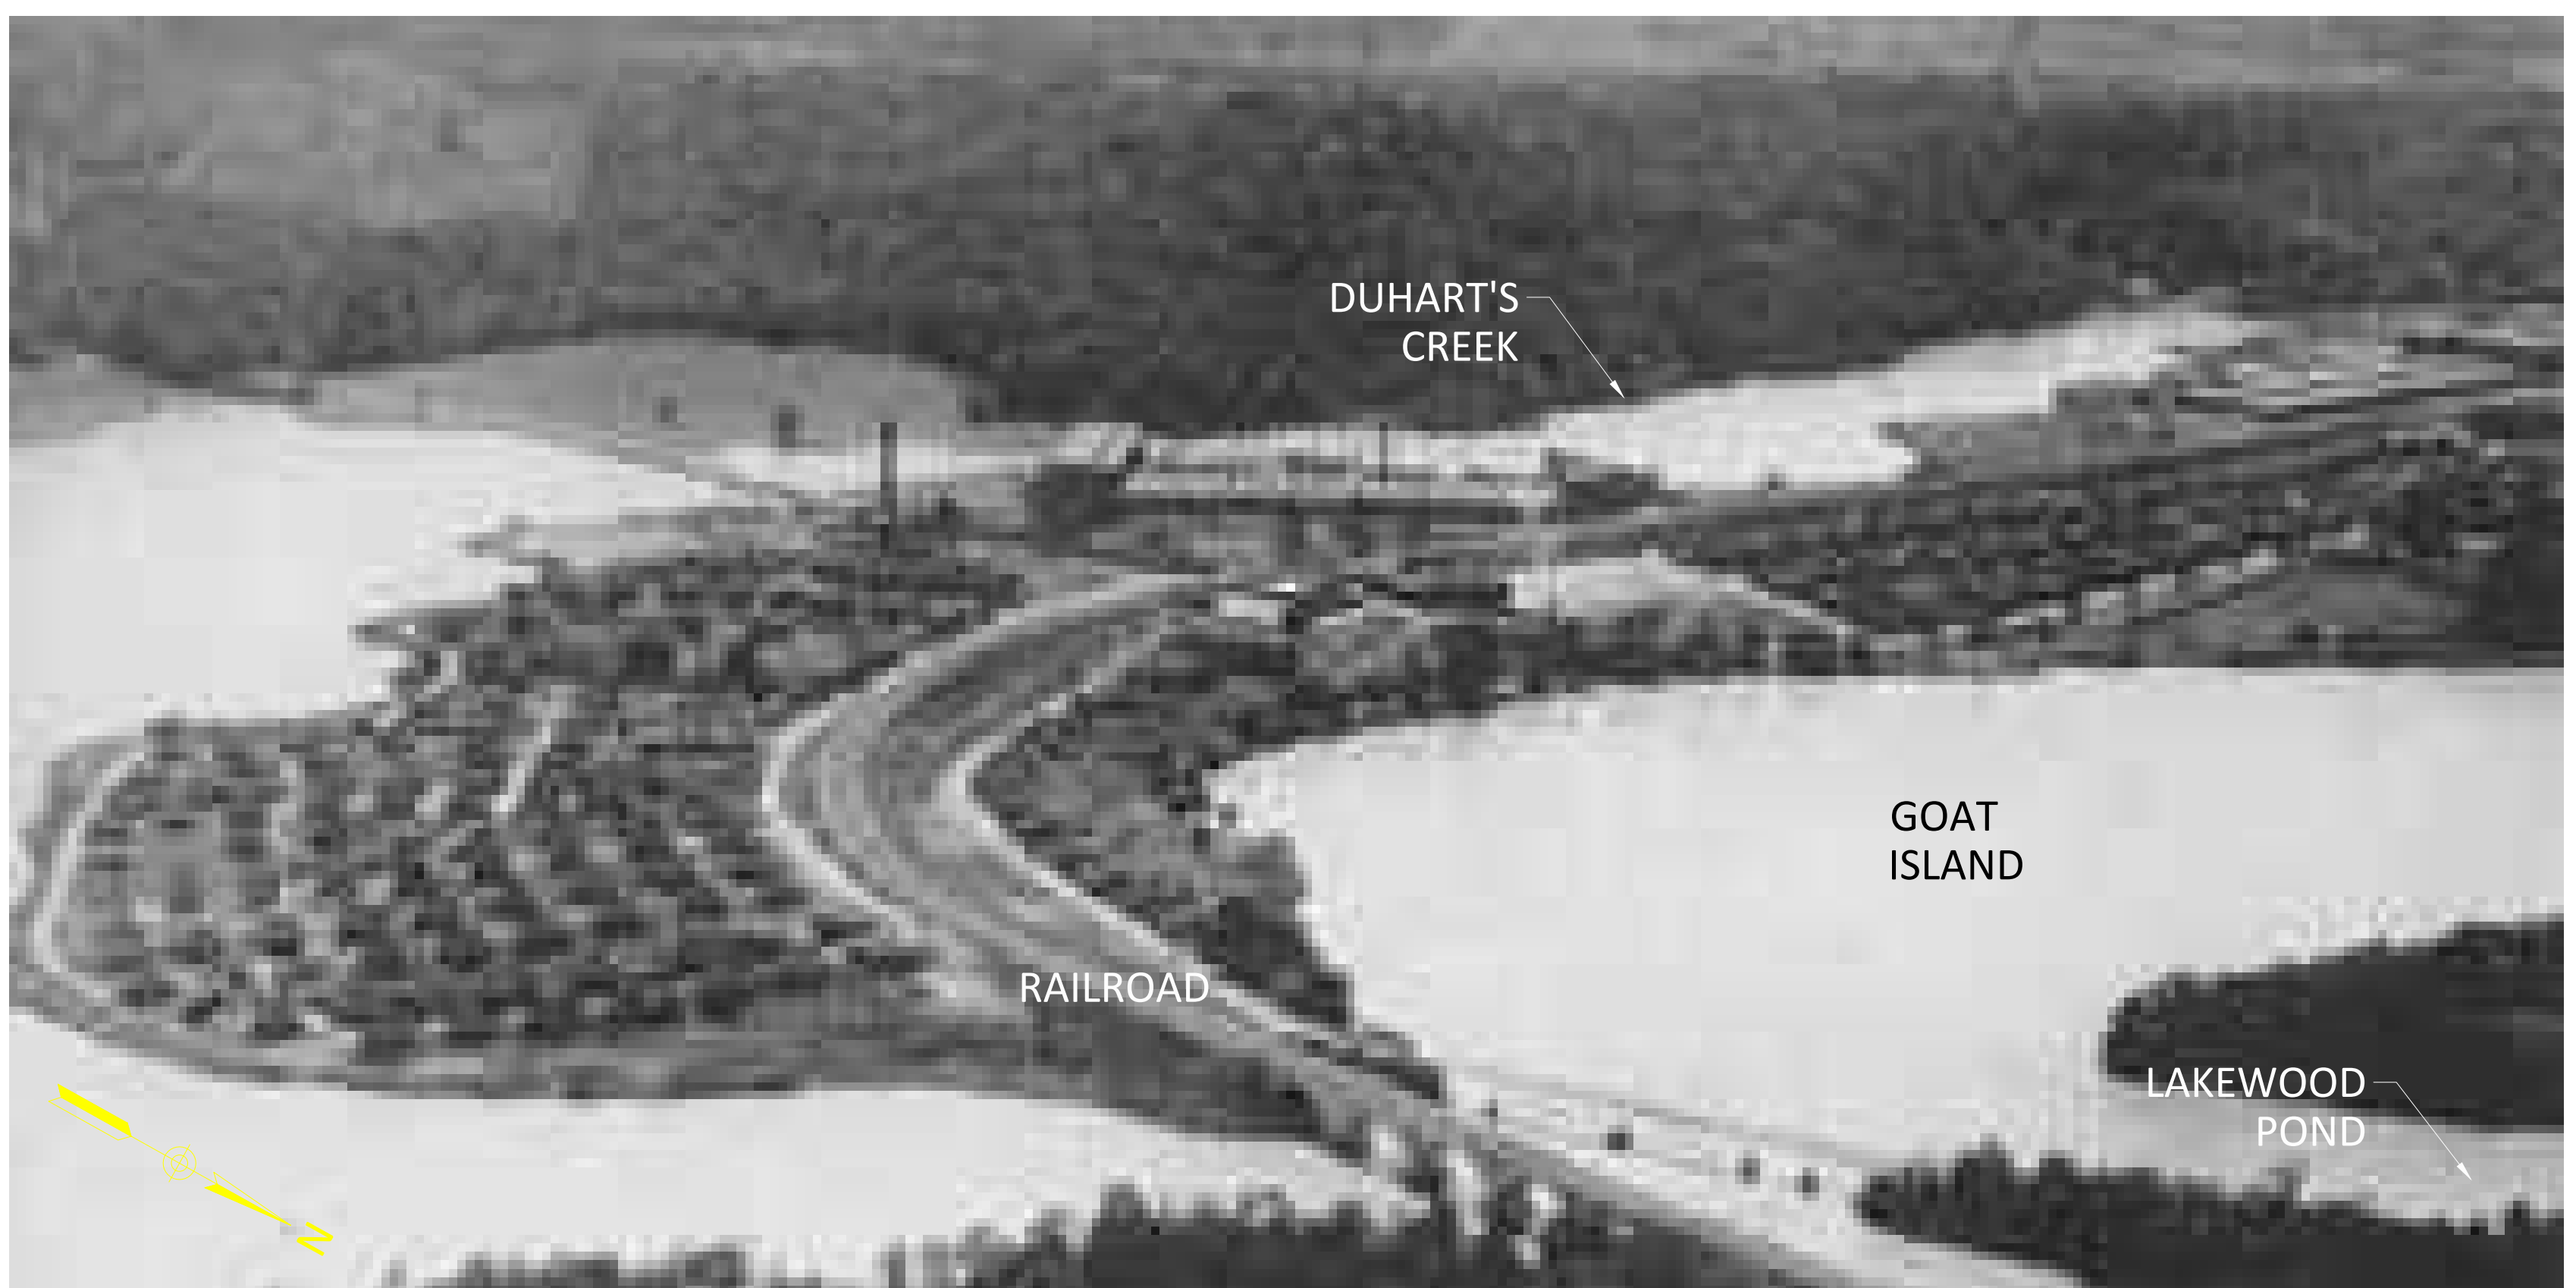
HISTORIC PHOTO OF CRAMERTON / CRAMERTON LAKE

*BASED ON PROJECT RESEARCH, THE LAKE WYLIE DAM IN ITS CURRENT CONFIGURATION CAME ONLINE IN AUGUST 1925. THAT SUGGESTS THAT THIS PHOTO WAS TAKEN PRIOR TO THIS DATE SINCE THE DOWNSTREAM LAKE WYLIE RESERVOIR IS NOT AT FULL POND IN THIS PHOTO. IT SEEMS LIKELY THAT THE TWO STRUCTURES WERE WORKED ON CONTEMPORANEOUSLY. THE 1904 LAKE WYLIE DAM WAS LOWER AND WAS DAMAGED IN THE 1916 FLOOD.

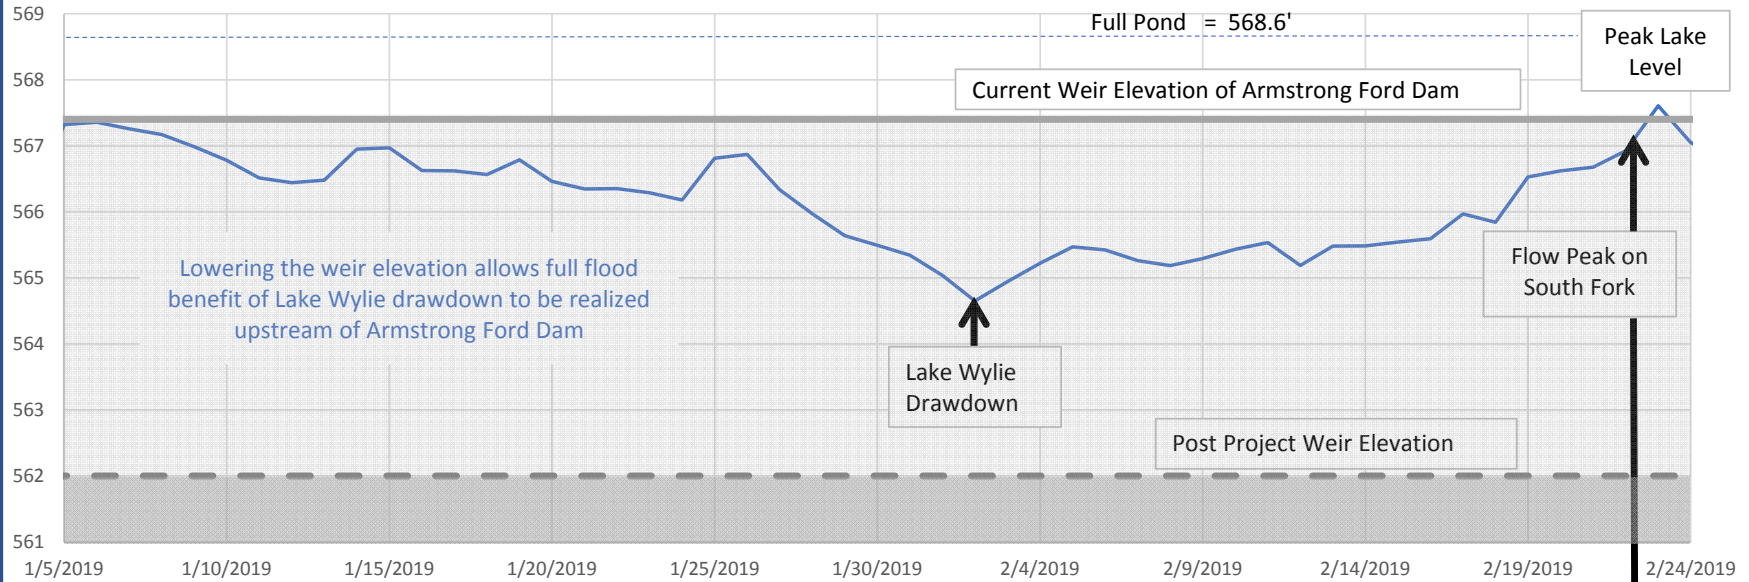
Lake Wylie Water Surface Elevations (NAVD88) February 2019 Flood Event

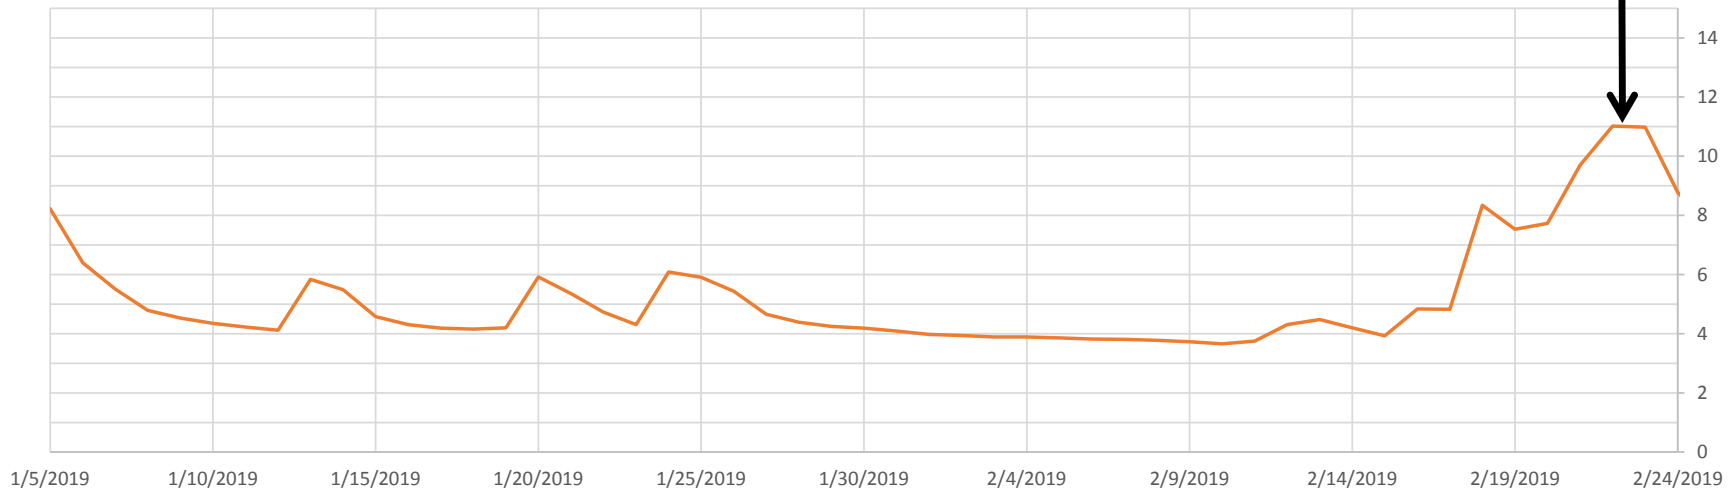
USGS Gage - South Fork Catawba River at Lowell - River Stage (feet above datum)

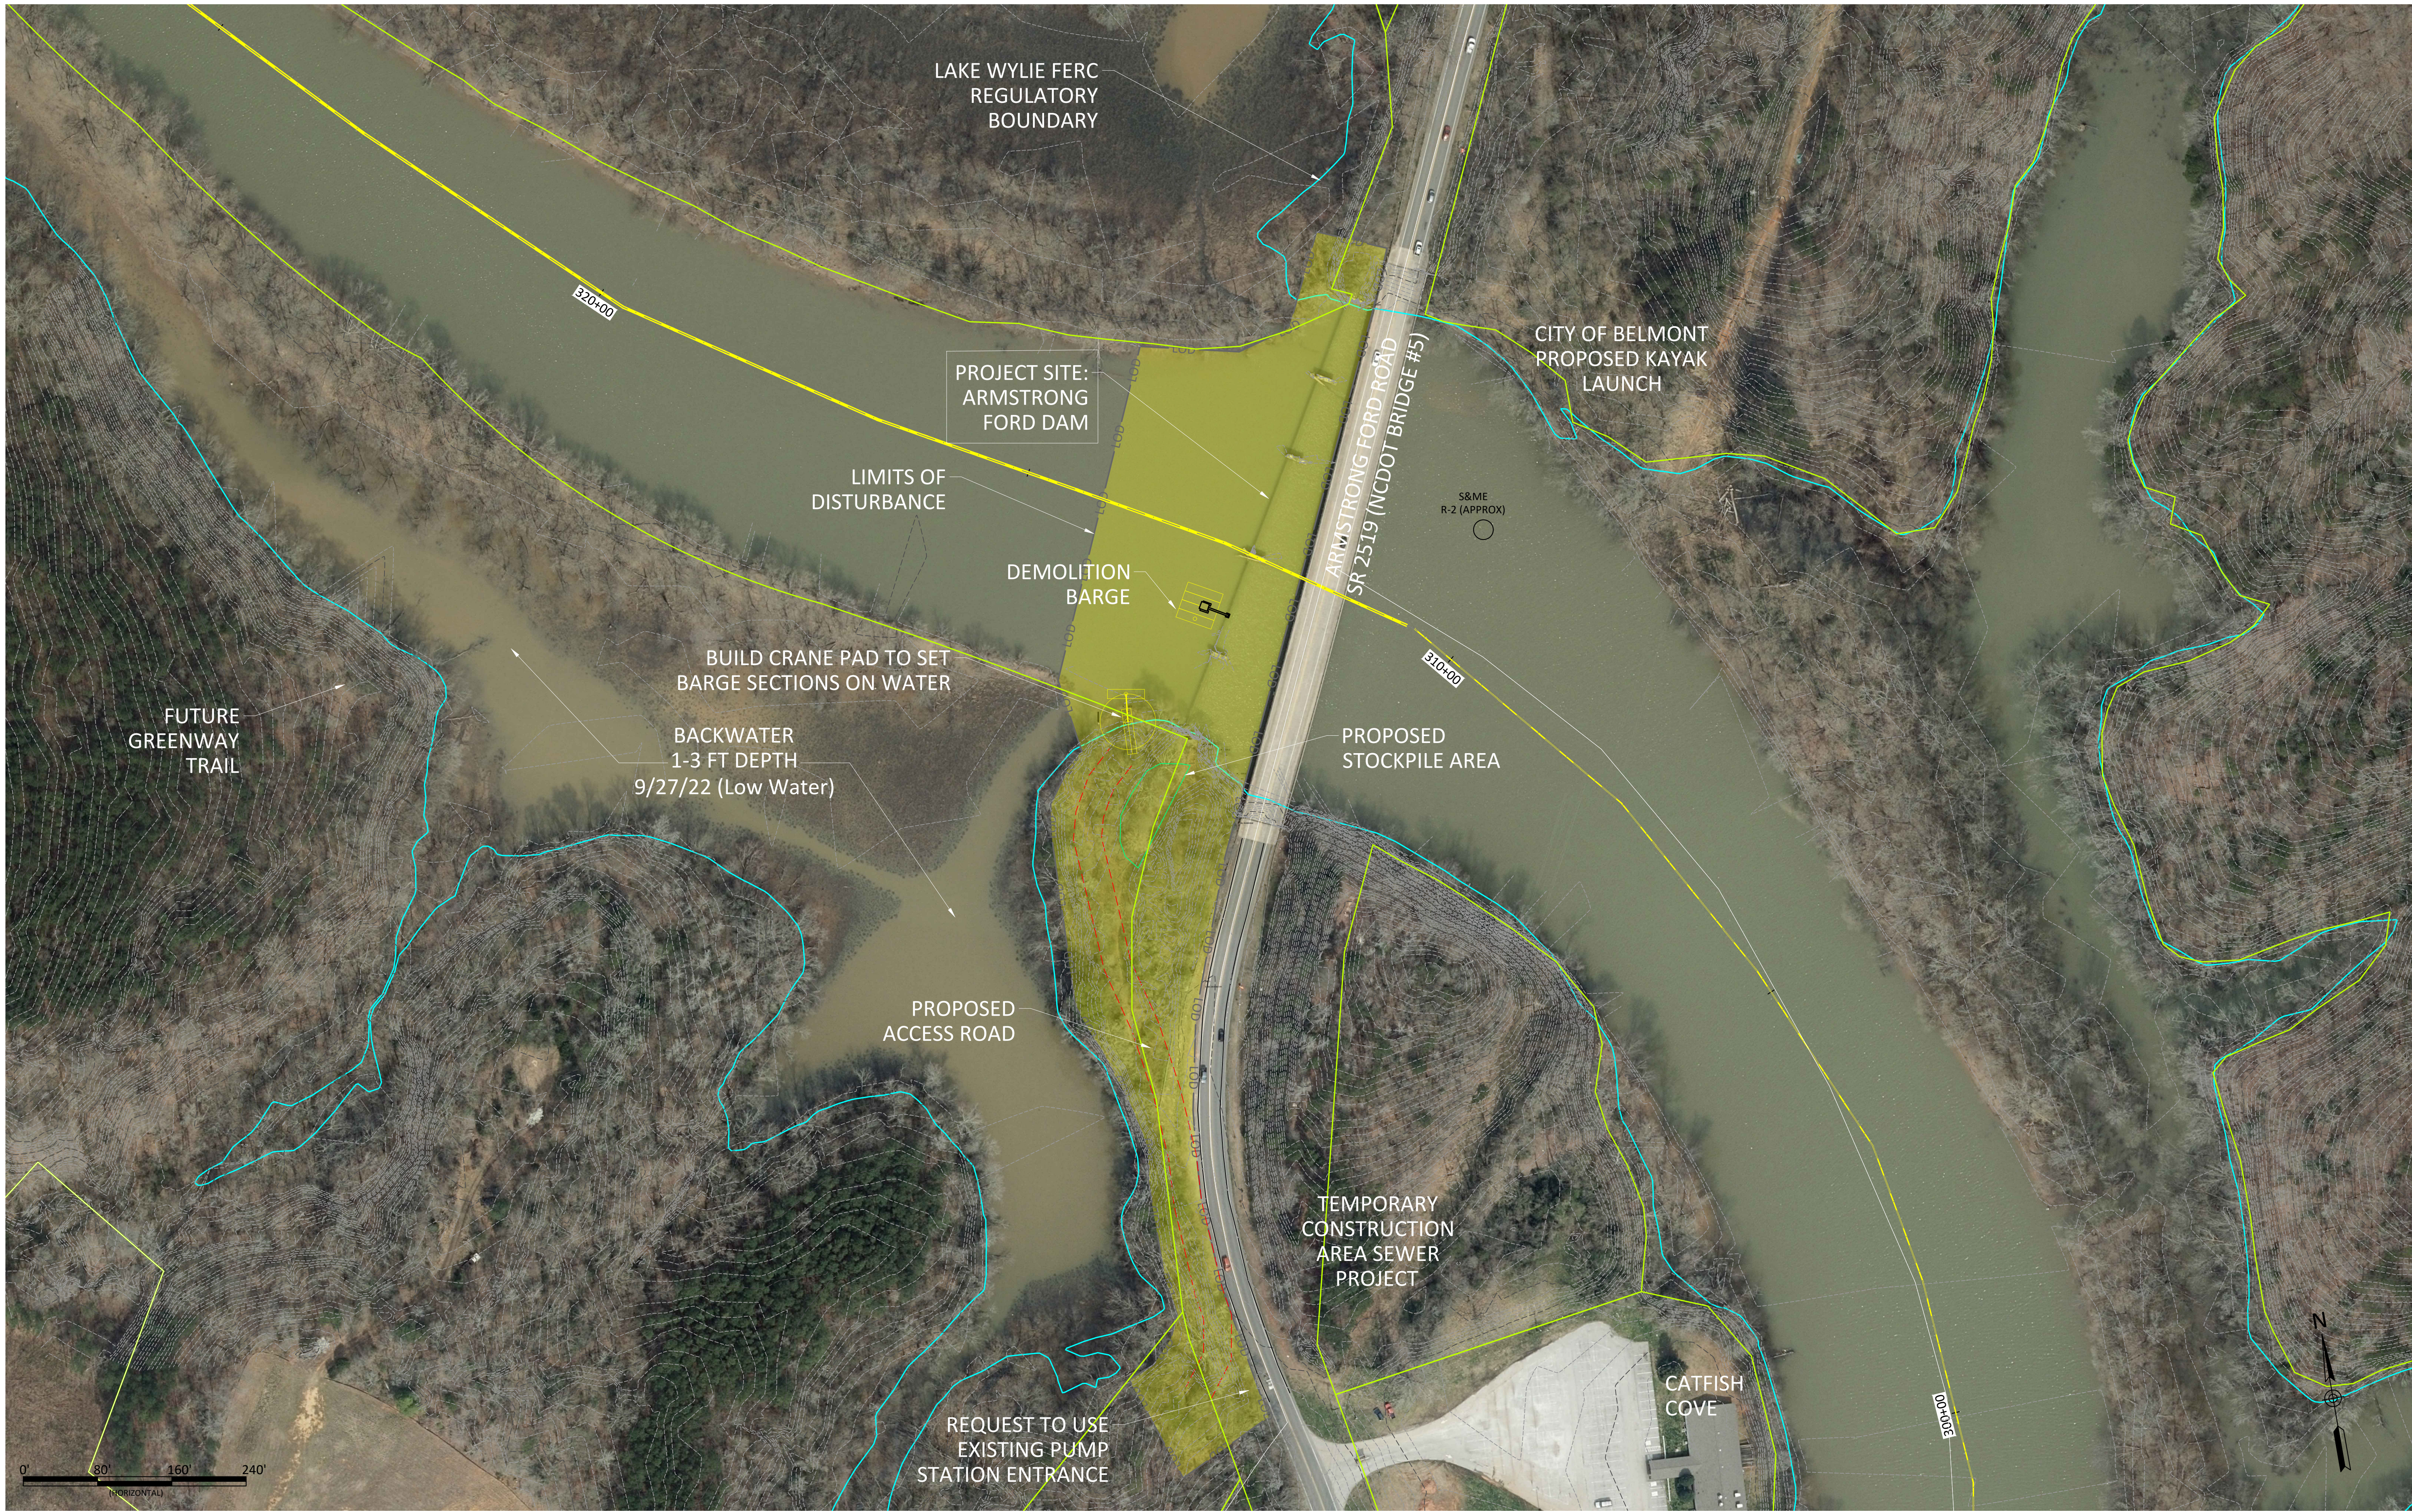
SITE PLAN

LAKE WYLIE FERC
REGULATORY
BOUNDARY

LIMITS OF
DISTURBANCE

DEMOLITION
BARGE

BUILD CRANE PAD TO SET
BARGE SECTIONS ON WATER

BACKWATER
1-3 FT DEPTH
9/27/22 (Low Water)

PROPOSED
STOCKPILE AREA

PROPOSED
ACCESS ROAD

TEMPORARY
CONSTRUCTION
AREA SEWER
PROJECT

CITY OF BELMONT
PROPOSED KAYAK
LAUNCH

FUTURE
GREENWAY
TRAIL

REQUEST TO USE
EXISTING PUMP
STATION ENTRANCE

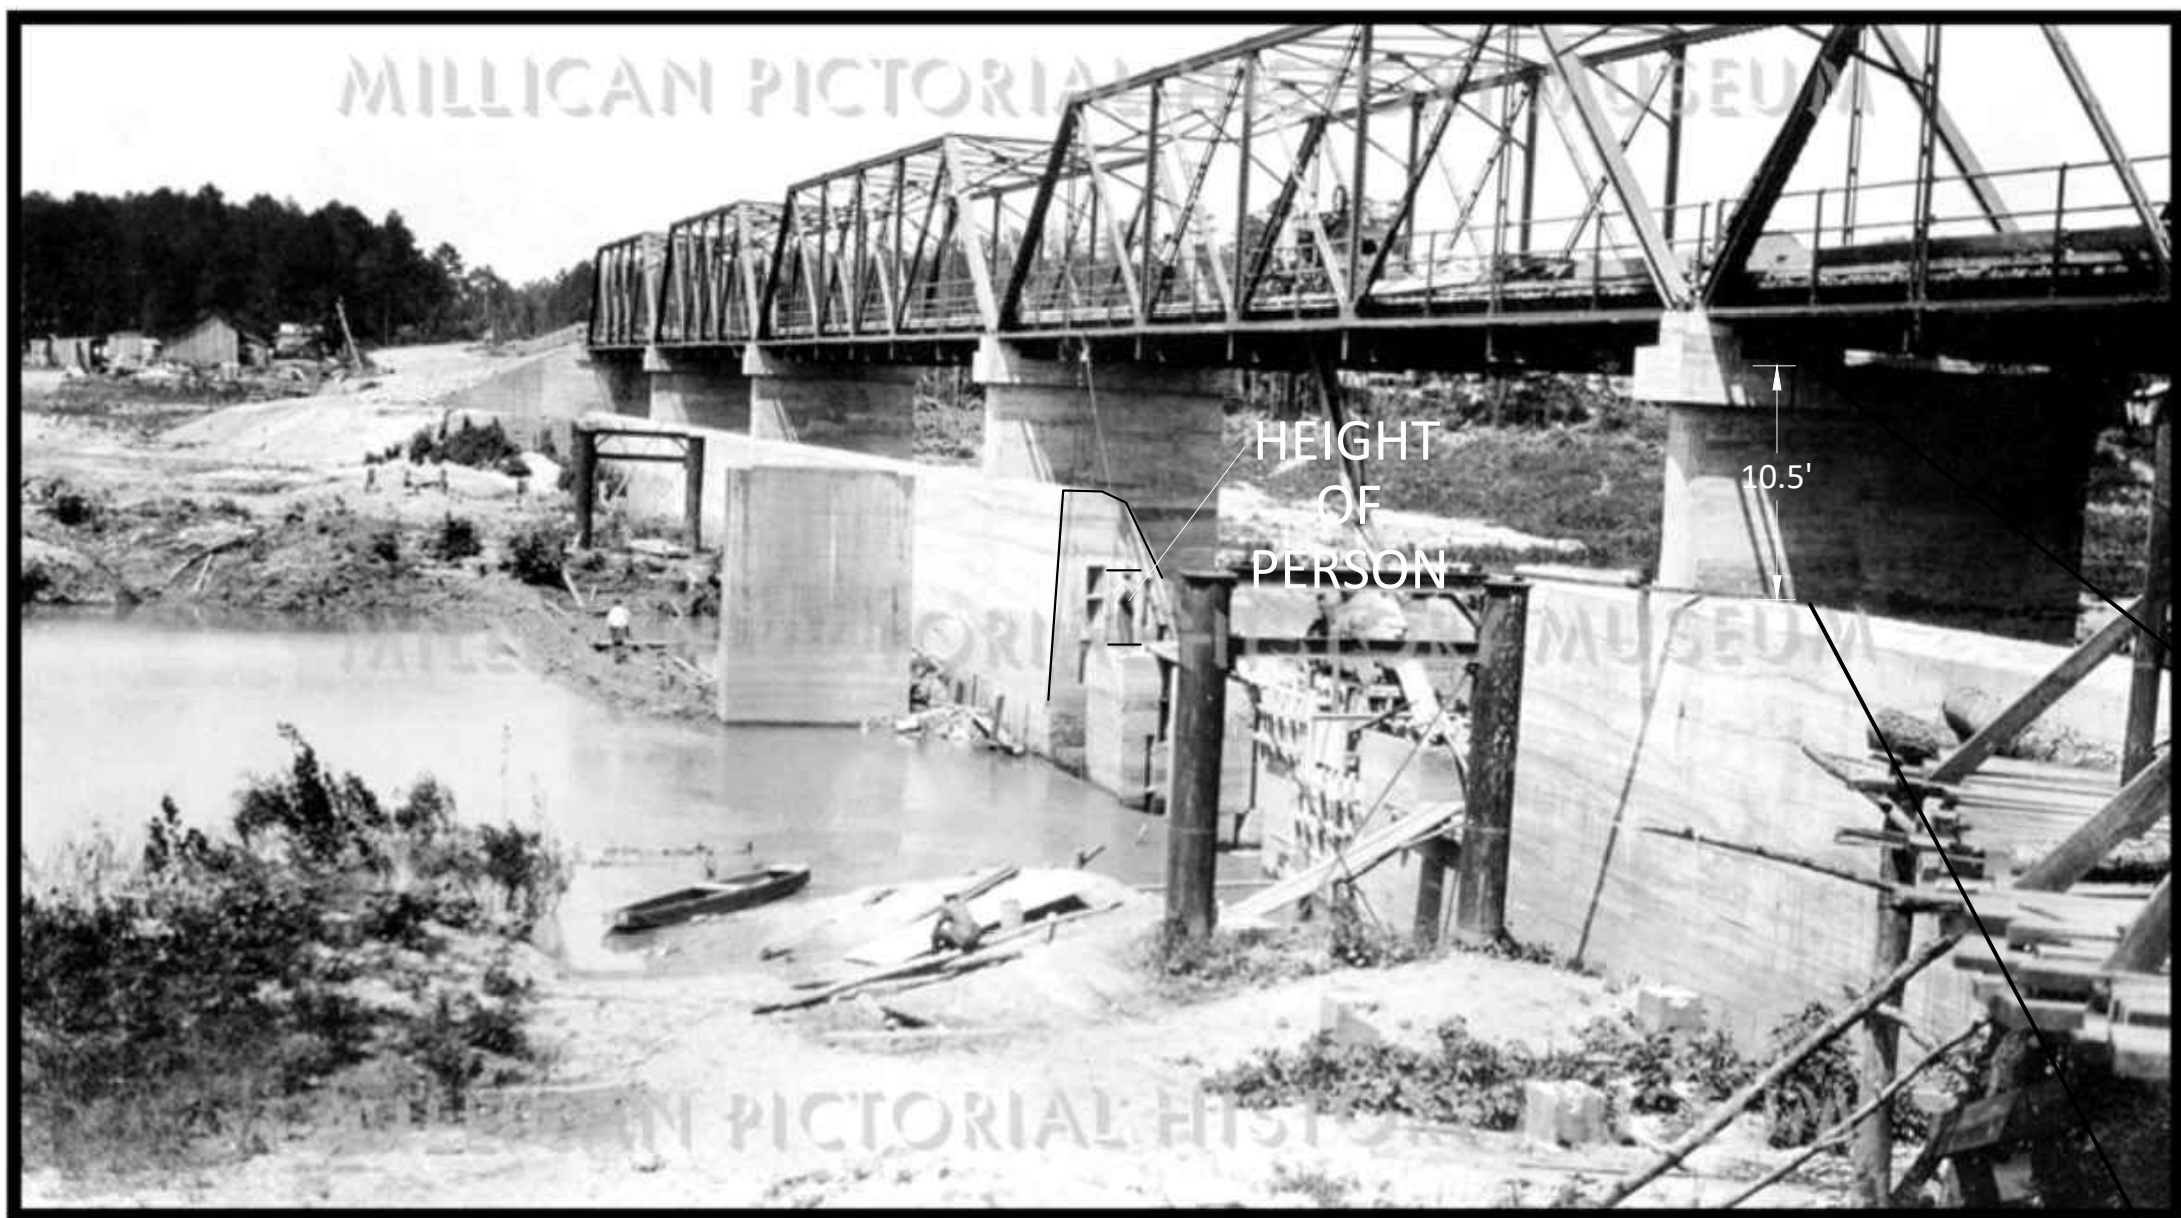
HISTORIC PHOTO DATED 1926* - UPPER ARMSTRONG FORD BRIDGE (MILICAN)

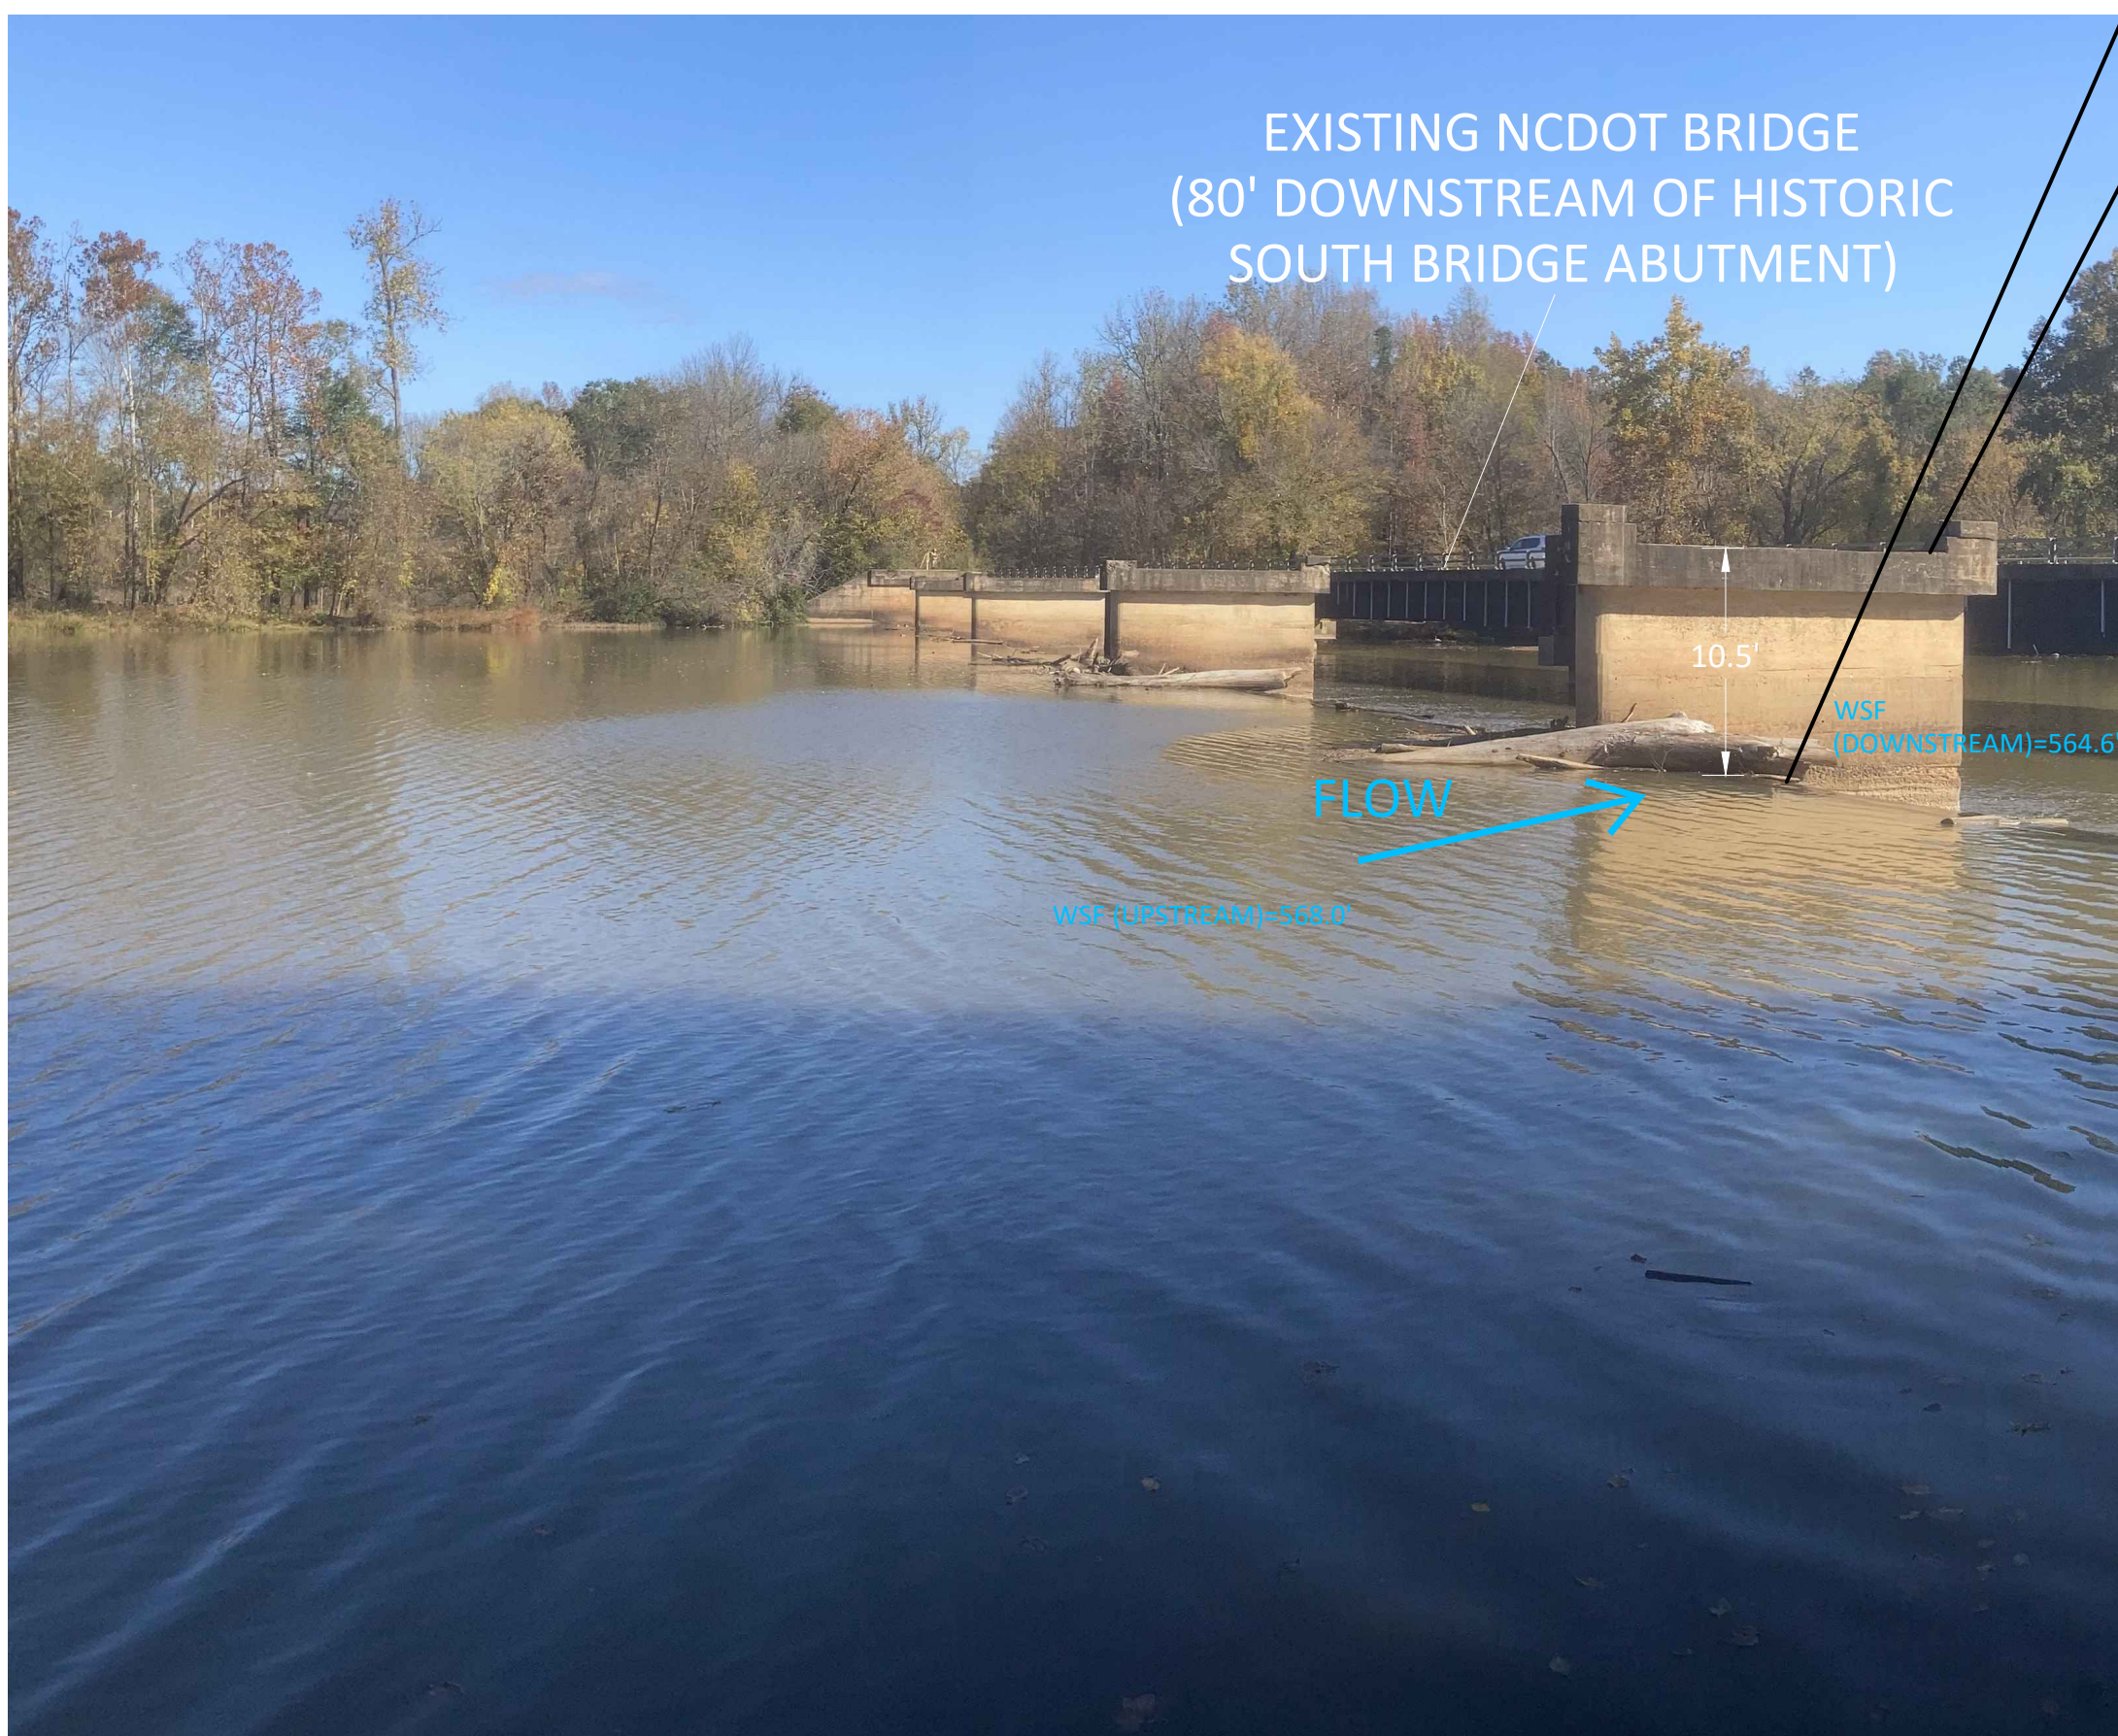
OCTOBER 2022 - SAME ORIENTATION AS HISTORIC PHOTO ABOVE
